### **RESIDUAL STRESS**

SURFACE TREATMENT

# Stress Analysis of Hydroxyapatite Coatings for Orthopaedic Implants

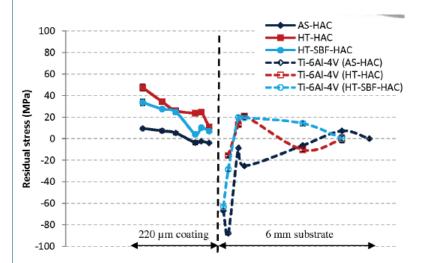
Fig. 2 Residual stress profile of HAC coatings with a Ti-6AI-4V substrate. The samples used were nanostructured hydroxyapatite plasma sprayed coatings on a titanium alloy substrate: as-sprayed (AS); heat treated (HT); heat treated then soaked in simulated body fluid (HT-SBF)).

The experiments were configured to determine the through-thickness residual strain profile of the coating-substrate system. Typical results of residual micro-strain are shown in Figure 2.

It was concluded that the combination of heat treatmentandexposure to simulated body fluid had a significant effect on the residual strain profiles in the upper layers of the hydroxyapatite coating.
